RAF UPPER HEYFORD

LAND QUALITY ASSESSMENT
PHASE ONE : DESK STUDY
FACTUAL REPORT

PROJECT NO: 07686
FINAL REPORT

January 1997

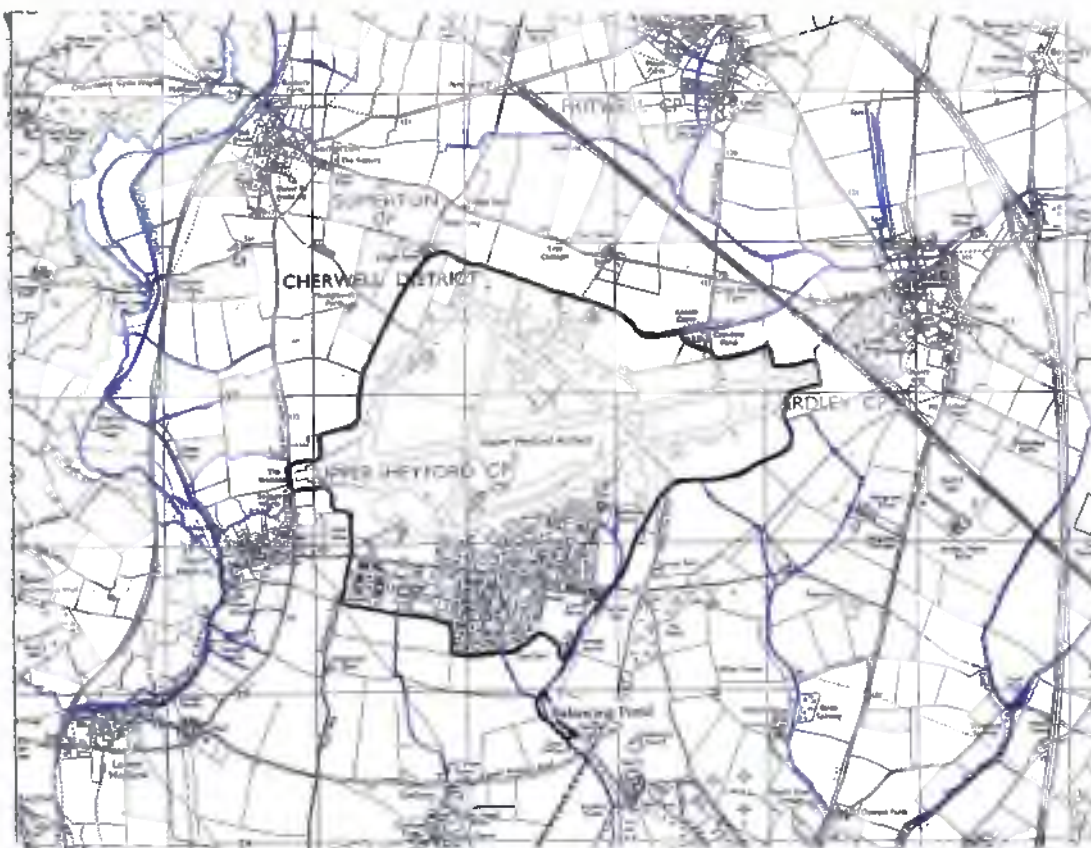
Scale	1:500
Page	3377.19
Fig	Figure 2.3a Surface Water Courses, RA2 Upper Heyford
Client

In addition to the Oxford Canal and River Cherwell to the west, at least five small streams drain radially away from the plateau. Draining southward are two branches of Gallos Brook as well as Gagle Brook, whilst towards the north and northeast are branches of a small brook which flows through Ardley. Finally, two tributaries flow westward off the plateau down towards the Oxford Canal. It should be noted that several of these small streams are spring fed and therefore dependant on groundwater discharges for flow. The Oxford Canal and the River Cherwell are classified as Class C (fair) according to the NRA's General quality Assessment (GQA) Scheme.

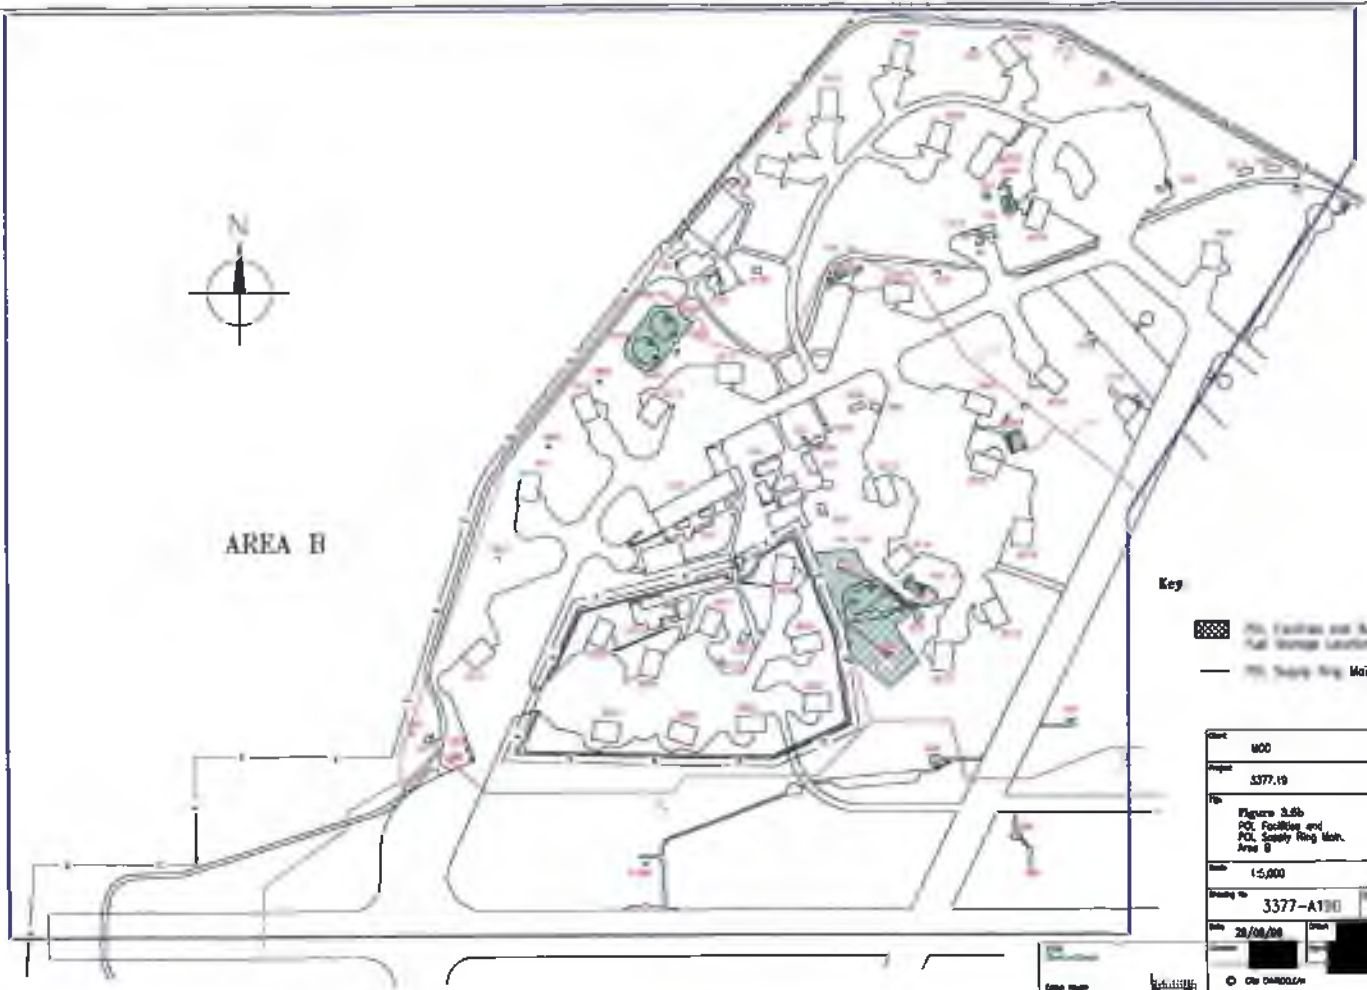
Client	MCD
Project	3377.19
Title	Figure 3.5b PDL Facilities and Fuel Storage Locations Area B
Scale	1:5,000
Drawing No.	3377-A100
Date	28/08/00
Drawn	[Redacted]
Checked	[Redacted]

During the site reconnaissance, all POL facilities were inspected for visual signs of potential contamination. All visible parts of the POL facilities were found to be thoroughly cleaned since the cessation of fuel storage and no surface evidence of contamination found.

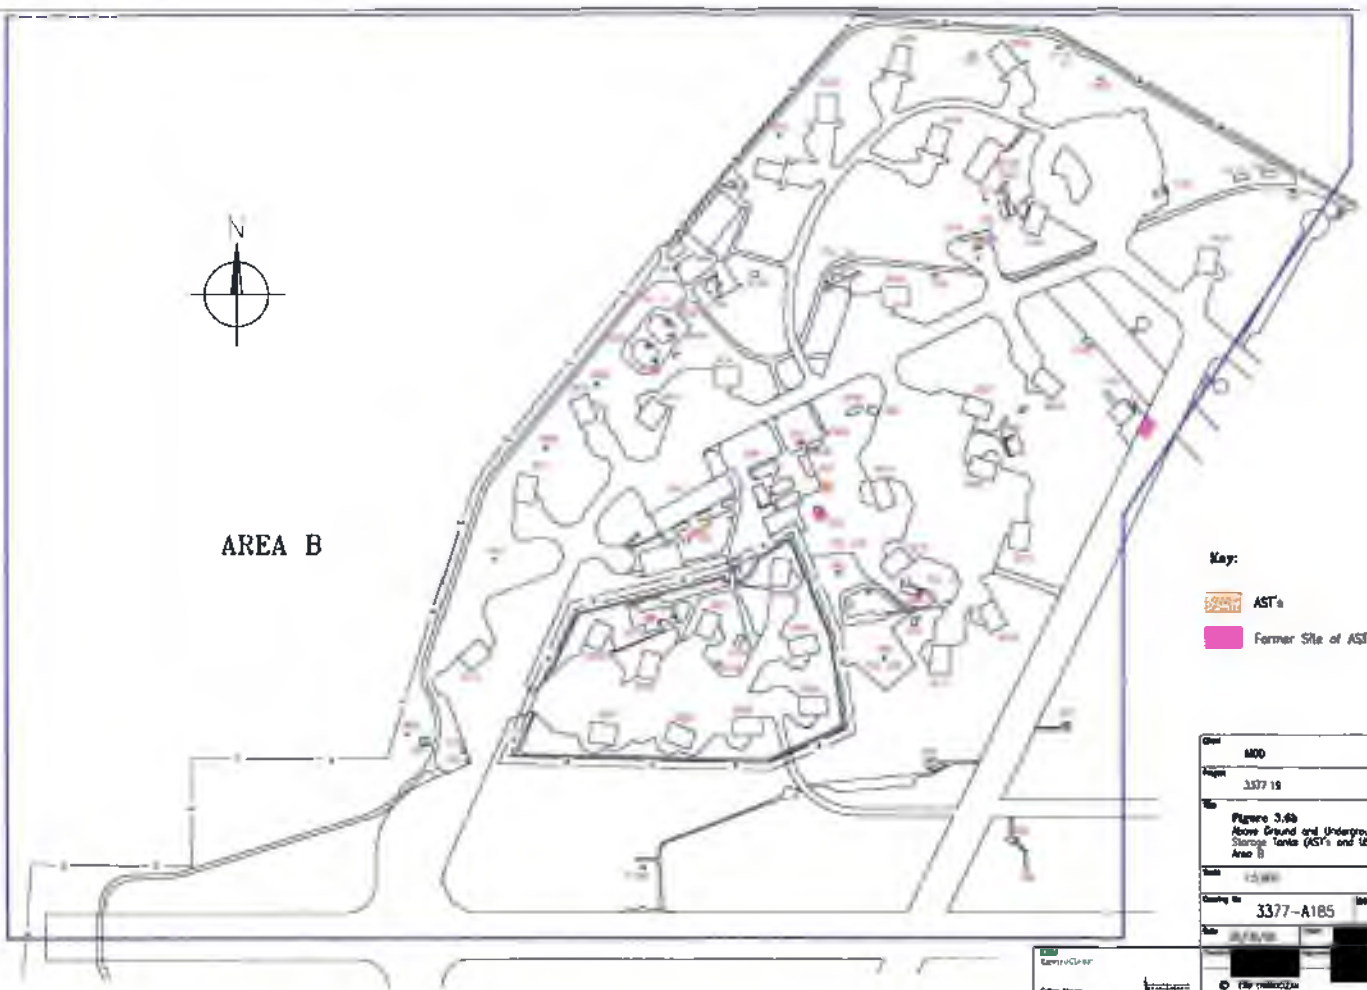
Client	MDD
Project	3377 15
Title	Figure 3.69 Above Ground and Underground Storage Tanks (AST's and UST's) Area B
Date	12/2011
Drawing No.	3377-A185
Scale	AS
Sheet	A

The locations of the above ground storage tanks observed during the site reconnaissance are shown in *Figures 3.6a, b, c d & e*. Details recorded during the ERM site visit are recorded in *Table 3.6a* below. In many cases, the AST's have been removed and only the bunding remains visible. MOD site personnel informed ERM that the gas mains supply was installed at the site in the mid 1980's and consequently many of the AST's became redundant.

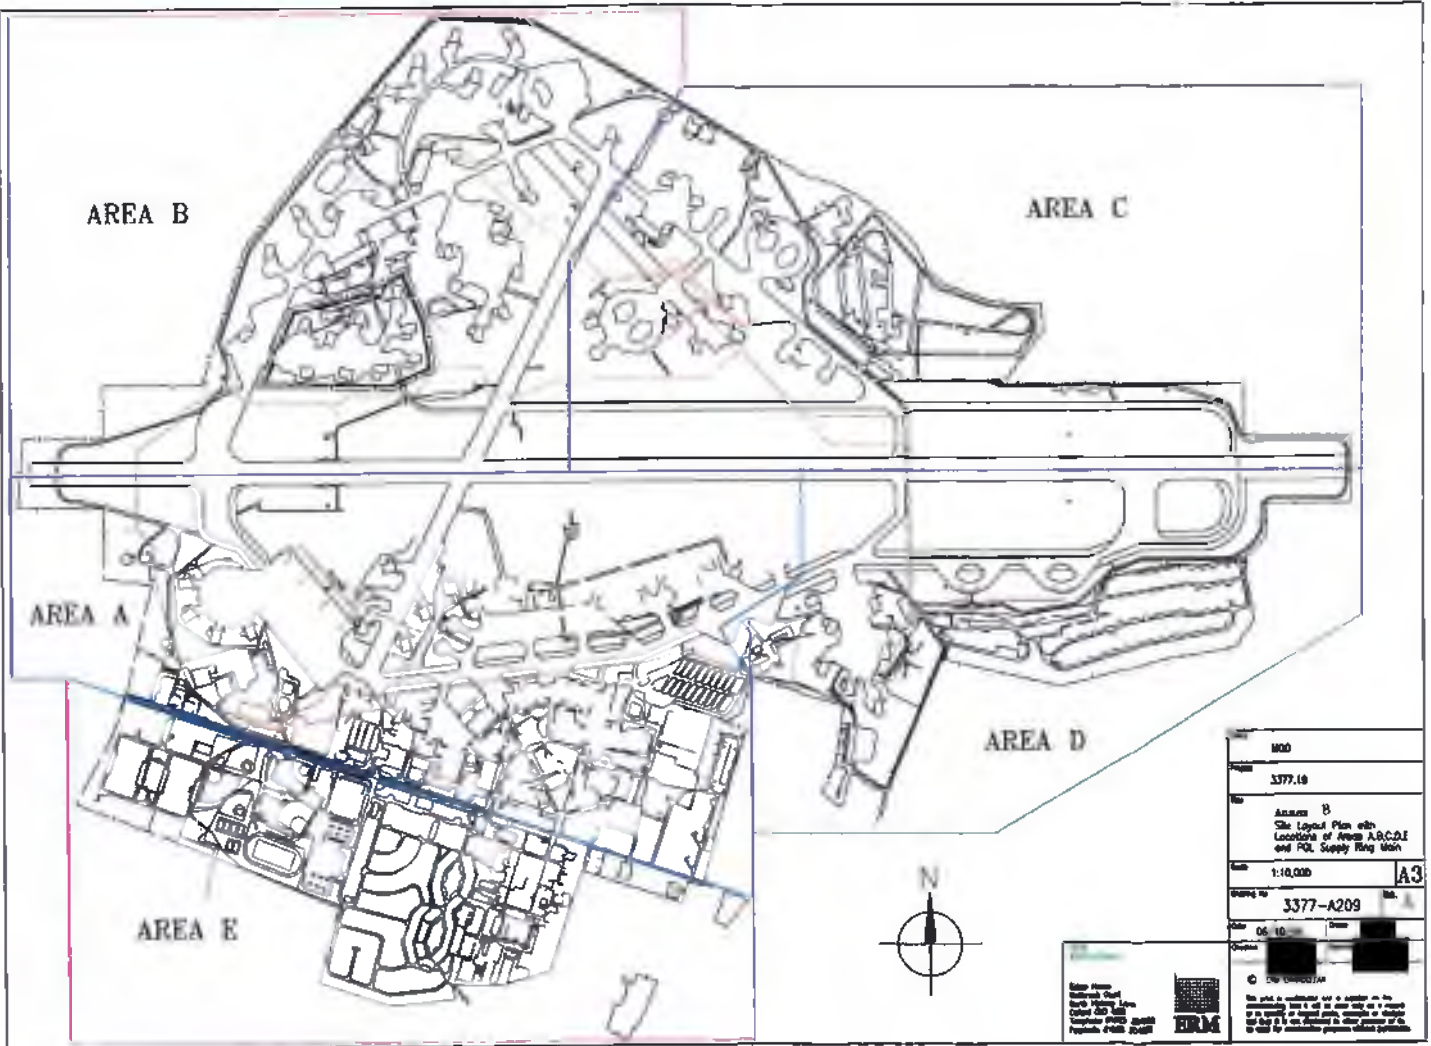
MOU	
Project	3377.10
Site	Annex B The Layout Plan etc. Locations of Areas A,B,C,D,E and PQL Supply Ring Main
Scale	1:10,000
Drawing No.	3377-A209
Sheet	A3
Author	
Check	
Drawn	
Checked	
Approved	
© 2010 ERM

The POL bulk storage facilities are connected by a subsurface POL supply ring main. An MOD supplied map provided as *Annex C* indicates the location of the ring main within the site area. MOD personnel on-site confirmed that the ring main connecting the POL facilities has been flushed through and water filled as part of the site decommissioning. No visual evidence of contamination of the groundmass could be observed as the pipeline is installed below ground level.
