**RAF UPPER HEYFORD
LAND QUALITY ASSESSMENT
PHASE TWO : INTRUSIVE SURVEY
FACTUAL REPORT**

PROJECT NO: 07686 - FINAL REPORT

**Technical Report
June 1997
by
Aspinwall & Company Ltd**

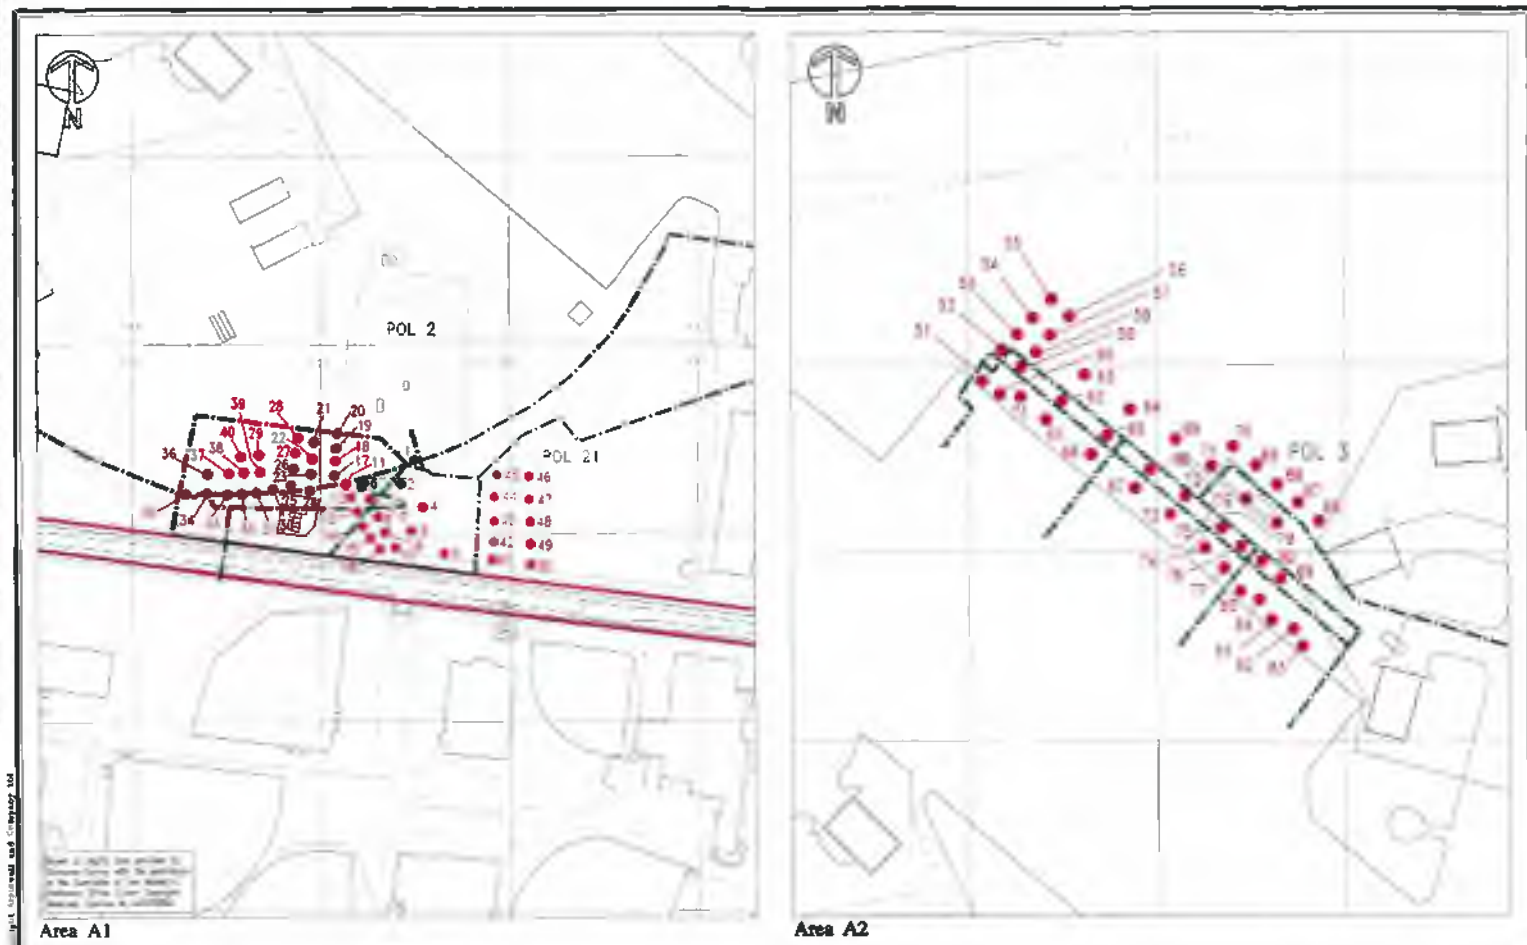
5, 5A

Soil Vapour Survey Sampling Points - Area A

- Boundary of Area A
- Soil vapour survey point
- POL supply ring main (taken from ERM desk study)

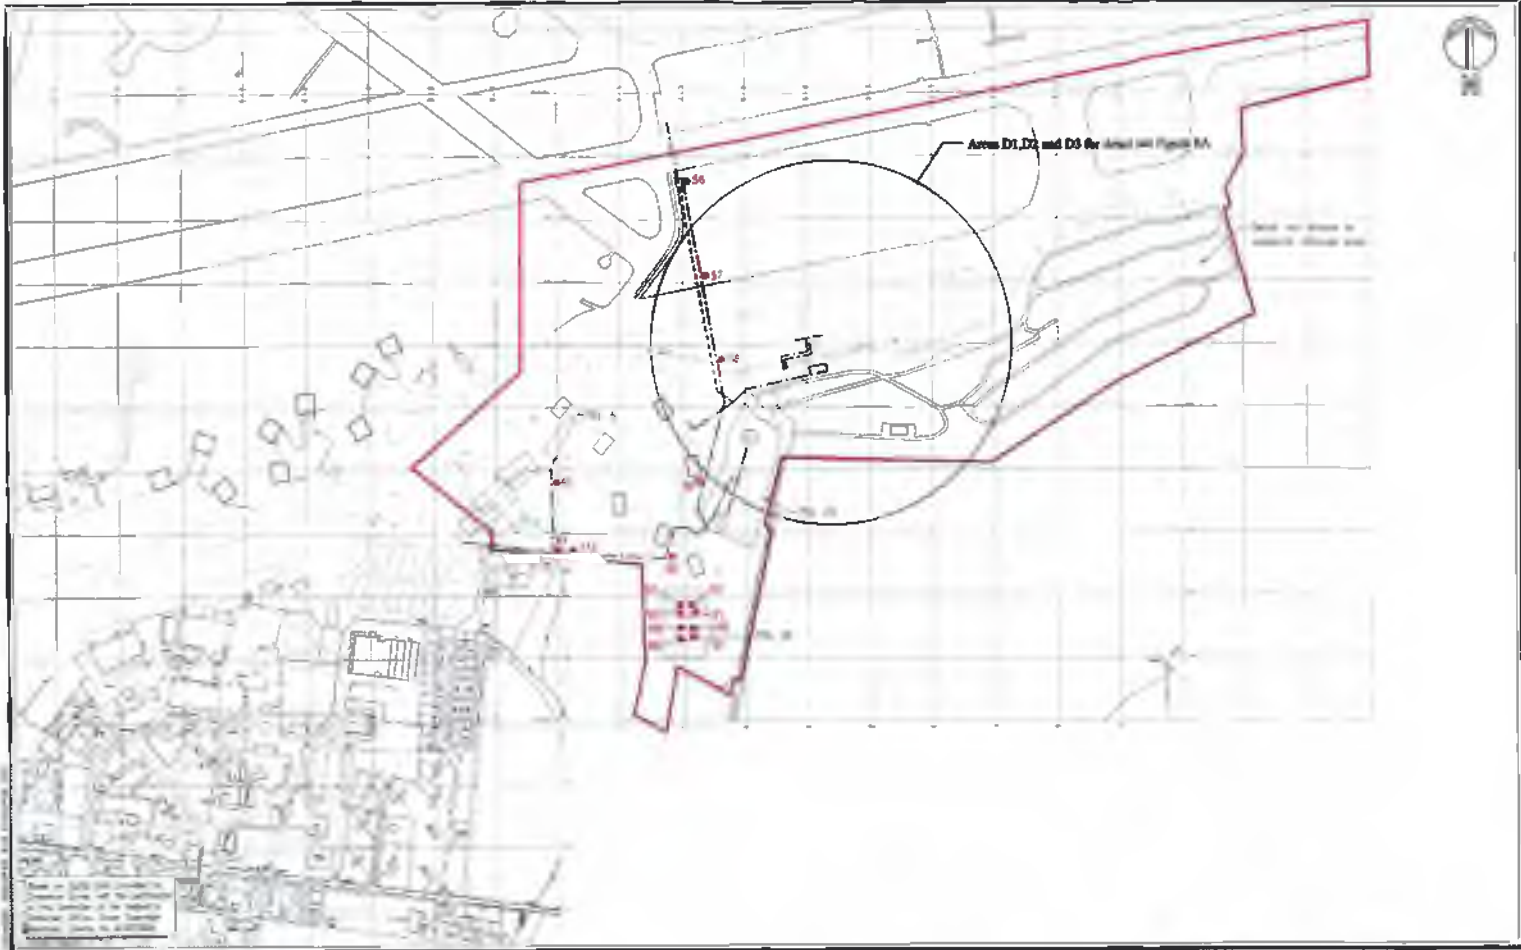
Soil Vapour Survey Sampling Points - Area D

- KEY**
- Boundary of Area D
 - Soil vapour survey point
 - PCL supply ring main (taken from ERM desk study)
 - PCL supply ring main re-routed from this previous location

FIGURE 8, 8A
Soil Vapour Survey Sampling Points - Area D
